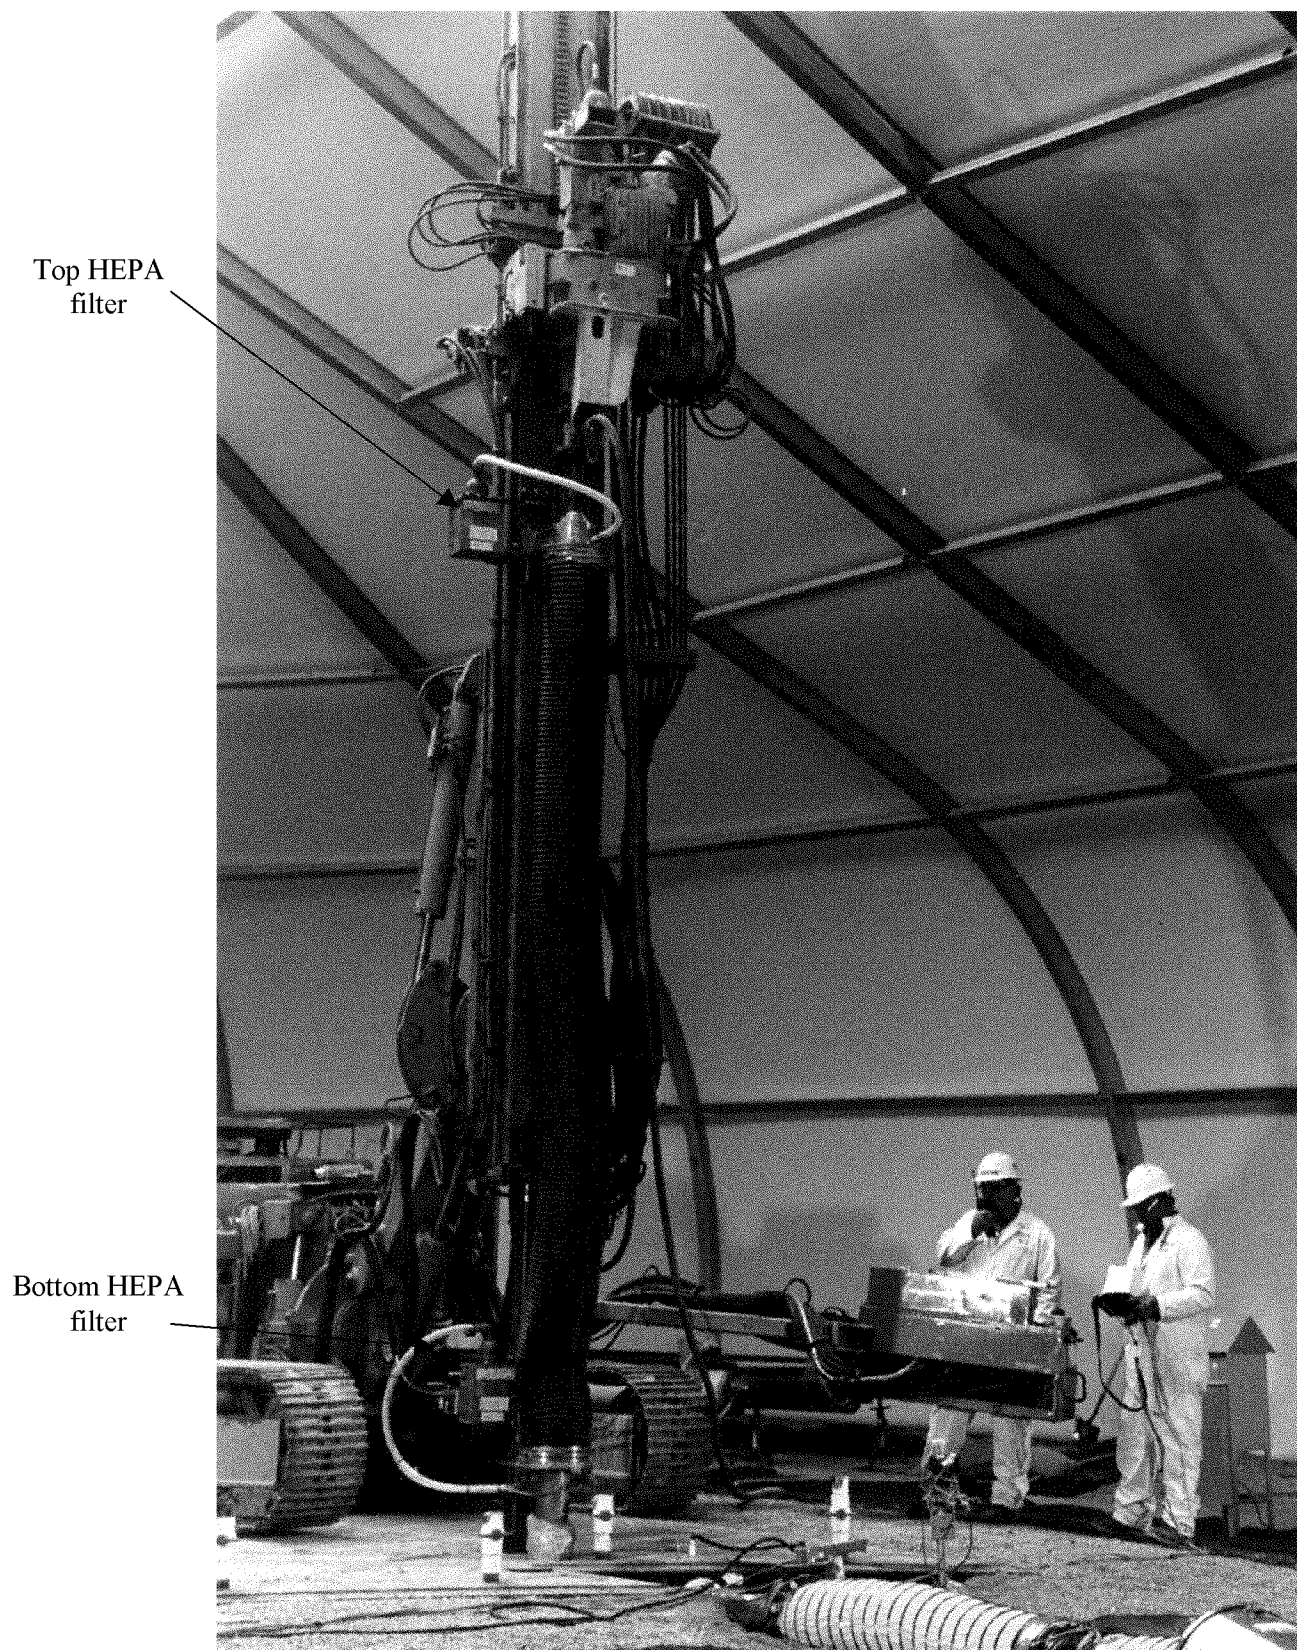
Figure 41 shows the passive HEPA filters on the inner and outer shrouds (one at the top for the space between the drill steel and the inner shroud and one at the bottom for the space between the inner shroud and the outer shroud).

Figure 41. Drill string being inserted into waste pit (Photo PN01-520-4-22).

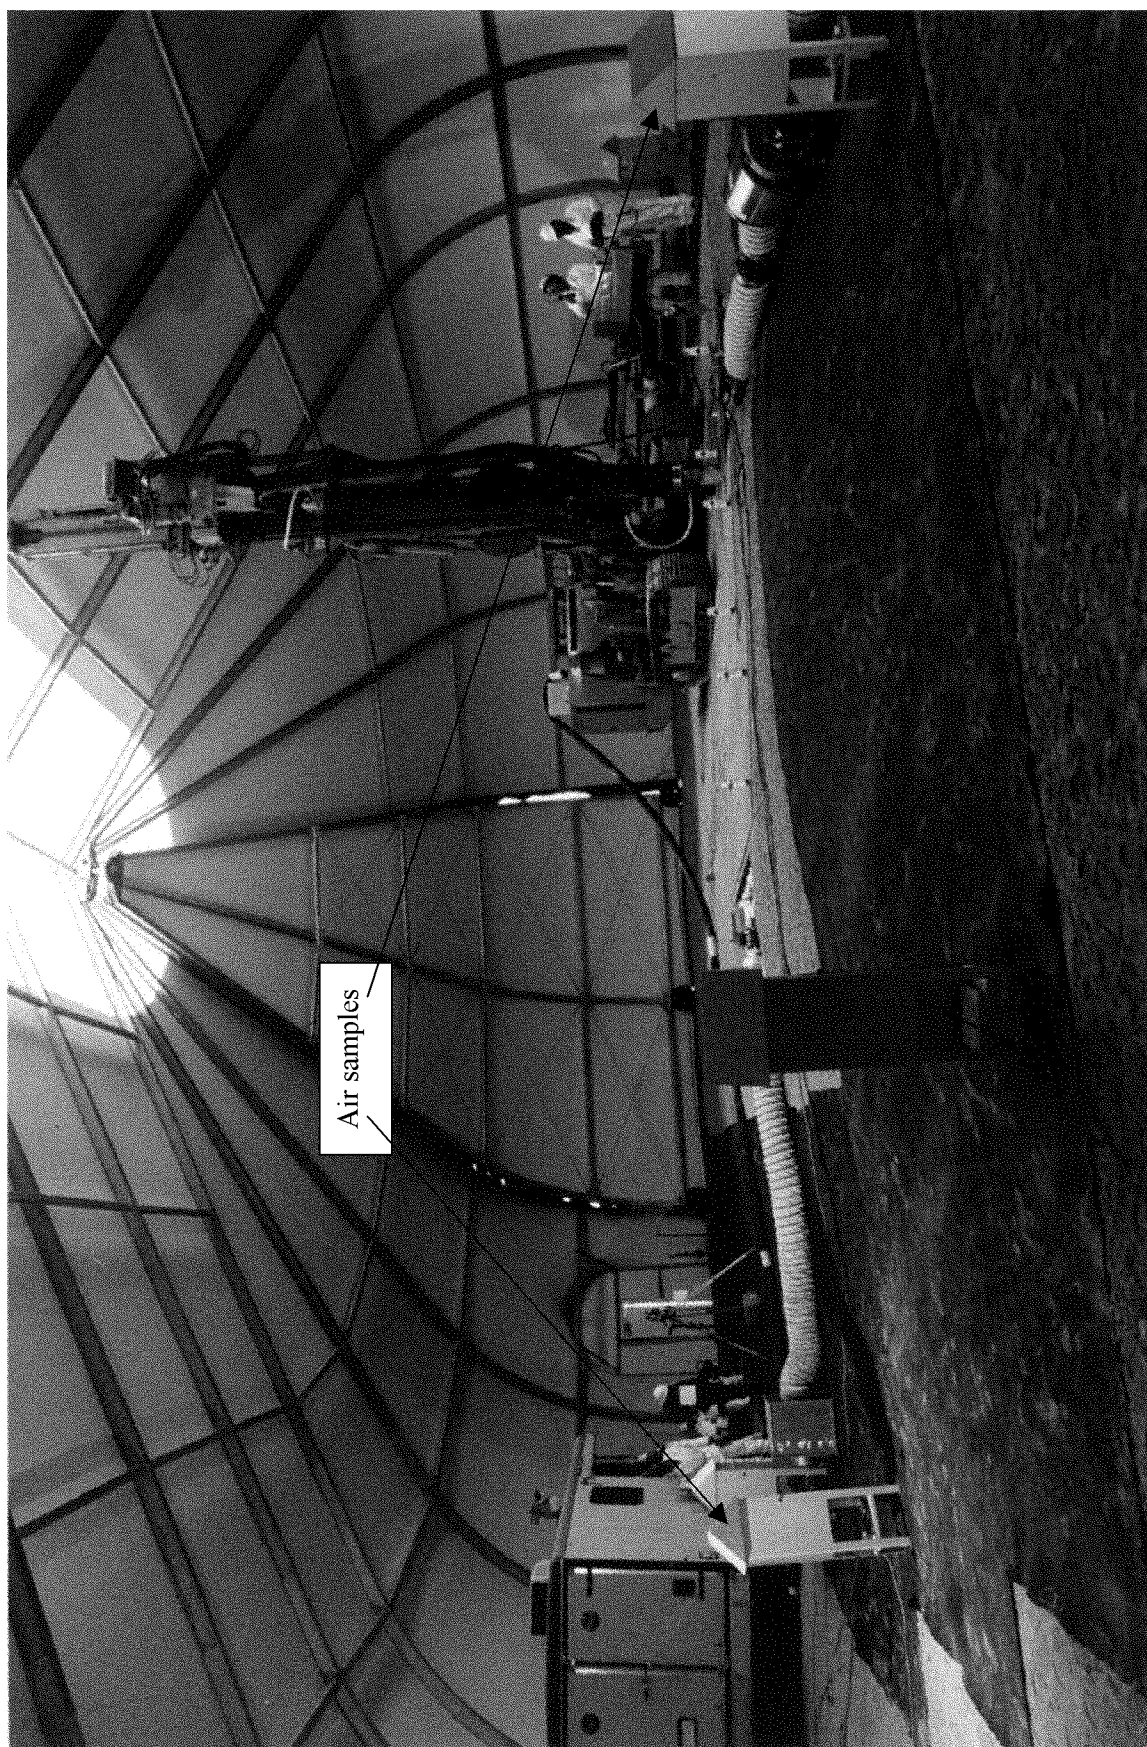
Figure 42 shows another view of the grouting operation with the strategically placed high volume air filters arranged around the thrust block.

Figure 42. Air samplers in weather structure (Photo PN01-520-4-25).

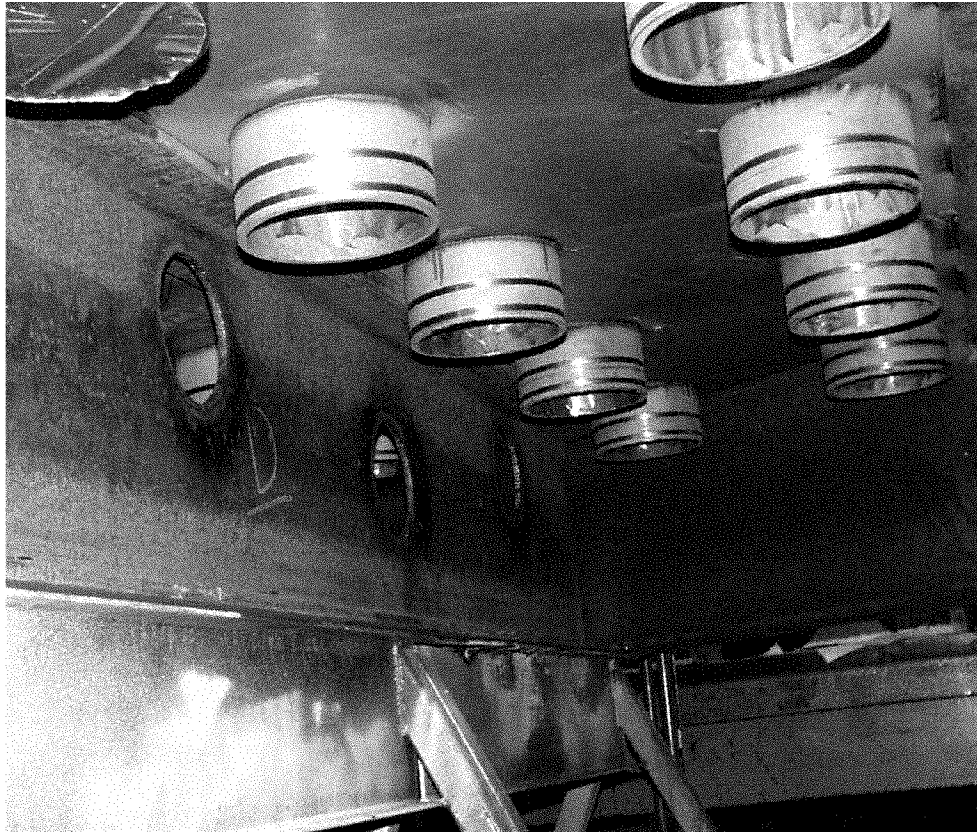
Another design feature of the thrust block included a Lexan viewing chamber for locating a remotely controlled Television Camera that extended down into the cavity under the thrust block. Since the thrust block consisted of separate panels allowing supporting “I” beams underneath, each panel had a viewing well. Within the well was placed a TV camera for online and recorded operations. This allowed monitoring of the amount of grout returns under the block during all phases of grouting. These data were feed back to a control trailer located within the weather structure and a second hand held viewing camera was utilized by the grouting operator. In this manner, excess grout returns could be visually monitored and the grouting operation could be immediately stopped if excess returns were observed. Figure 43 shows a view underneath the thrust block which is essentially the view as seen by the camera.

Figure 43. View underneath thrust block.

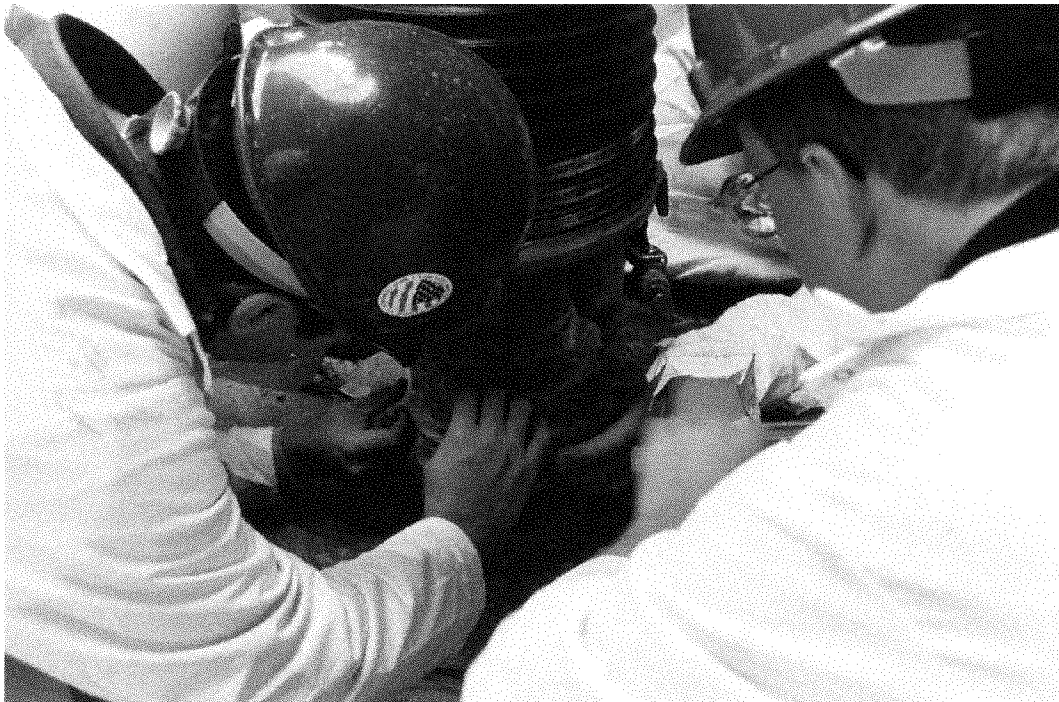
- Place a strap wrench on the bottom of the double bags to keep the two bags from extending into the hole when the bags were placed on the stinger.
- The inner bag was sealed onto the stinger at a high point using plastic strapping, folded over, and forced down to the next lowest point (shown in Figure 44).

Figure 44. Placing plastic sleeve material on drill string stinger (Photo PN01-520-4-10).

- The outer bag was then also strapped with plastic straps, folded over and also pulled down to the line of the elevation of the inner bag.
- When the inner and outer bag were in position, the strap wrench was removed and the drill string was inserted breaking the lower plastic diaphragm.

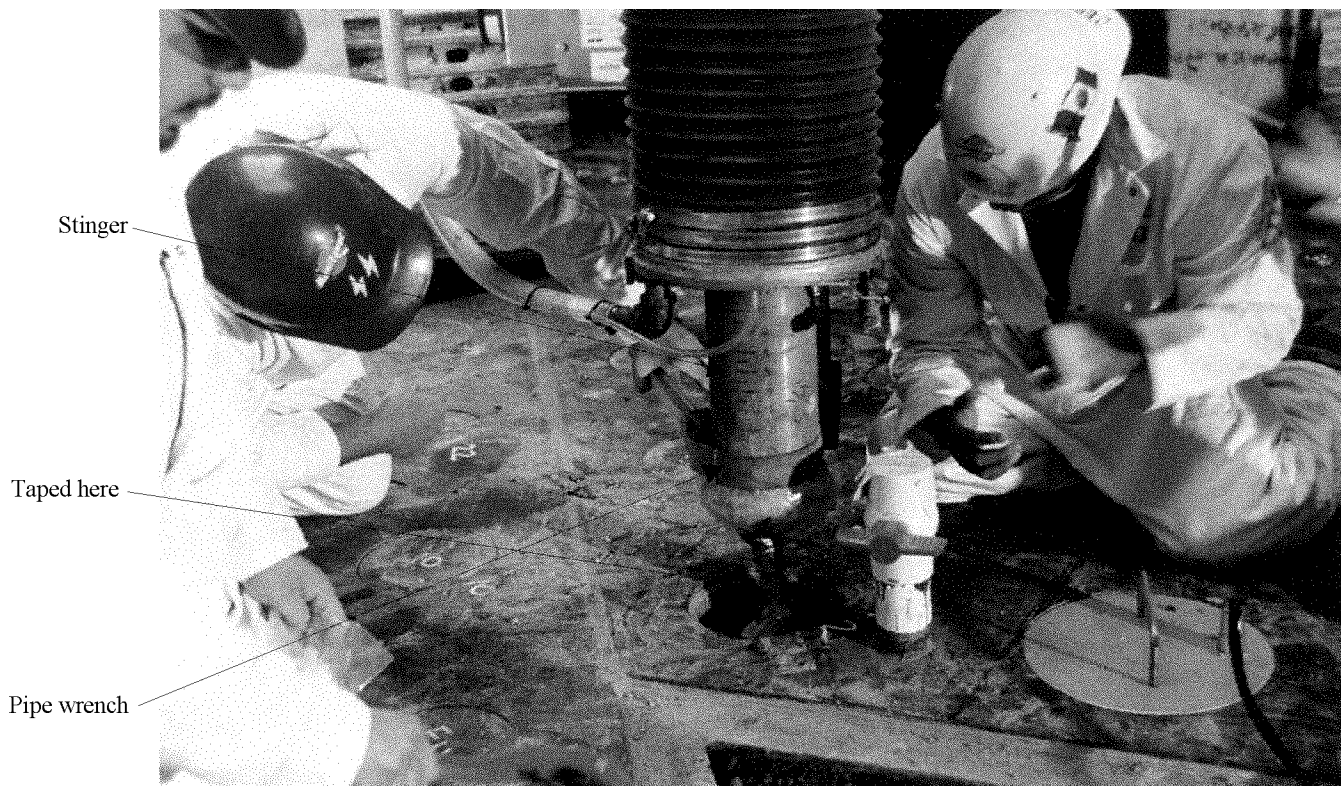
- The bag was twisted off and taped (shown in Figure 45).
- The twist off and taped area was cut with either a pipe shear or a special heat knife.

Figure 45. Twisted and taped plastic sleeves ready to cut (Photo PN01-520-5-2).

- This procedure was repeated until the number of plastic bags (upper part of the bags) on the stinger filled the approximately 35 cm (14 in.) of surface. It is noted that the last bag still had a twisted and taped bottom thus maintaining contamination control.
